NASA
Technical Paper 1561

AVRADCOM
Technical Report 79-28

**Preliminary Study of Methods
for Providing Thermal Shock
Resistance to Plasma-Sprayed
Ceramic Gas-Path Seals**

Robert C. Bill, Donald W. Wisander,
and David E. Brewster

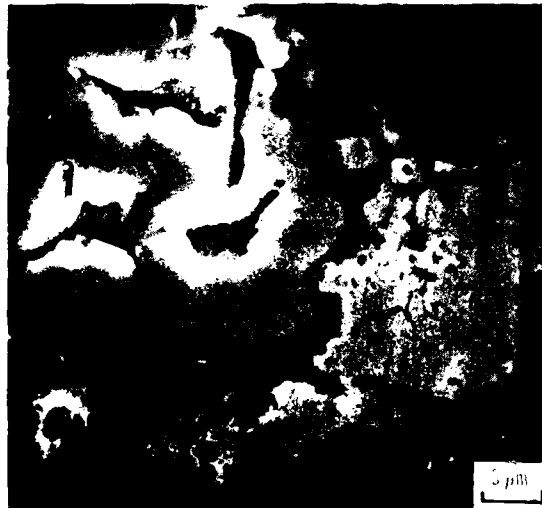
(a) As sprayed; X250.

(b) After 50 hours at 927° C; X250.

(c) After 50 hours at 927° C; X3000.

Figure 8. - Photomicrographs of YSZ-NiCrAlY layers as sprayed and after exposure at 927° C for 50 hours.

Optical photomicrographs (figs. 8(a) and (b)) of sections through the cermet layers in the as-sprayed condition and after exposure to $927^\circ C$ in air for 50 hours show some interesting comparisons. In the as-sprayed condition, the interiors of the NiCrAlY particles were clean and pore free and the interfaces between metal and ceramic particles were quite well defined. After the layers had been exposed to $927^\circ C$ for 50 hours, fine pores were apparent in the interior of the metallic particles, and the interfaces between the metal and ceramic particles had become broader and had a "fringed" appearance. Higher magnification SEM photographs (fig. 8(c)) verify the interior porosity and show a distinct separate phase filling the interface between the metal and ceramic particles. The average thickness of this "interfacial phase" after 50 hours at $927^\circ C$ is about 1 micrometer.

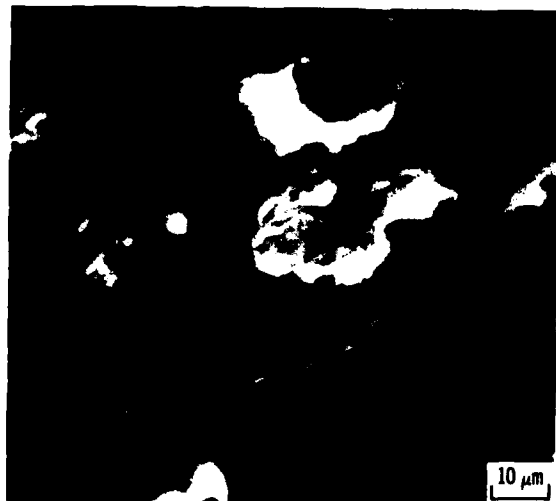
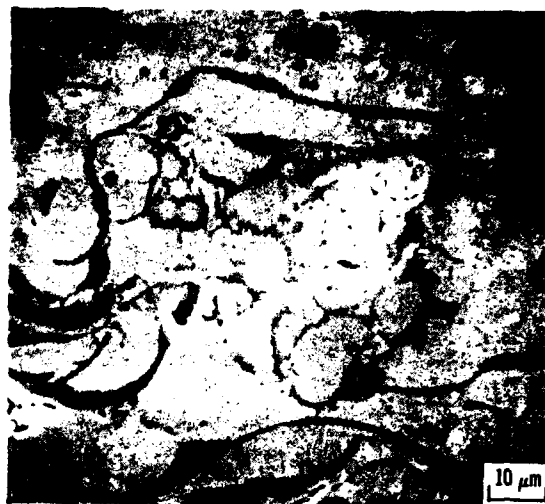
(a) After 200 hours at 760° C.

(b) After 50 hours at 982° C.

Figure 11. - Effect of thermal exposure on microstructure of 20YSZ-80NiCrAlY layers. Of particular interest are thicknesses of interfacial diffusion zones between metallic and ceramic particles.

Samples that were exposed in air to 760° C for 200 hours and to 982° C for 50 hours are shown in figure 11. The thickness of the interfacial phase after 200 hours at 760° C was difficult to measure, but it was estimated to be about 0.1 micrometer. After 50 hours at 982° C the interface was 1.5 to 2.5 micrometers thick.

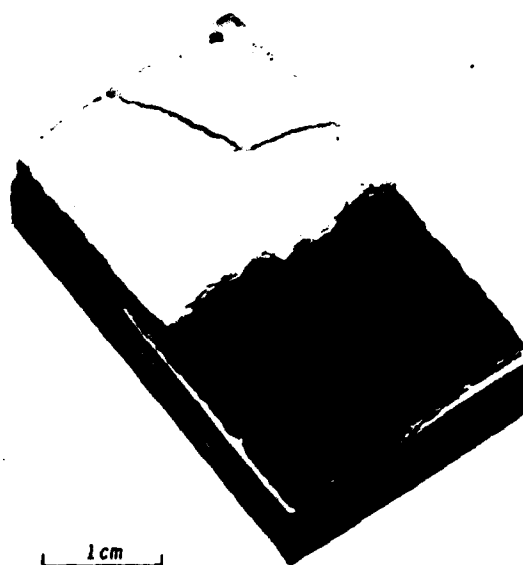
C-79-664

Figure 14. - LM-3 specimen after 79 thermal shock cycles, showing failure in low-modulus material.

The specimens incorporating a sintered Hastelloy-X pad with a modulus of about 1724 MPa (250 000 psi), designated "LM-2," survived an average of 30 thermal shock cycles before failure. This in itself would hardly seem to indicate the effectiveness of further reducing the modulus of the pads. However, no mudflat cracking of the ceramic occurred and, in fact, the sintered metal itself failed. Thus, there may have been some enhanced strain isolation effectiveness. Details of this failure mechanism are discussed in a later section. In essence though, the Hastelloy-X sintered fiber-metal failed right under the ceramic layer because of excessive temperatures. The temperature at this interface was estimated to have reached 1000° to 1050° C. The appearance of the failure is shown in figure 14.

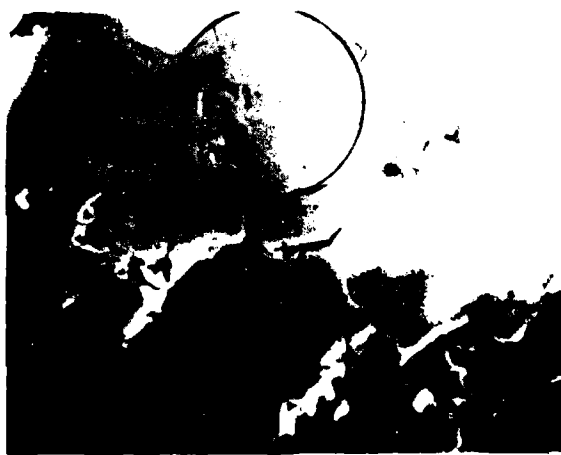
(a) Bond coat at ceramic interface after 455 thermal shock cycles. Note spongy, porous structure.

(b) Elemental analysis of ceramic, showing presence of nickel, iron, and chromium from bond coat and substrate. Aluminum peak coincides with zirconium peak.

Figure 16. - NiCrAlY-YSZ interface in LM-1 specimen after 455 thermal shock cycles.
